CASTLECRAG GRIFFIN RESERVES ACTION PLANS

INVENTORY OF **WALKWAYS AND DRAINAGE RESERVES ACTION PLANS** 2024

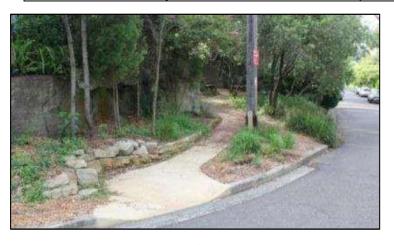
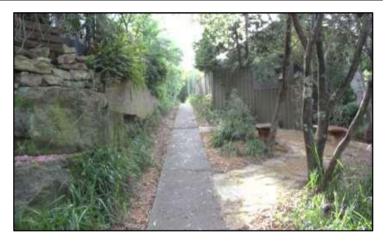
W-2- Between 4 The Postern and 31 The Parapet - access to Cortile Reserve

Width 3.05m. Concrete walkway 700mm wide. Curved path entrance maintains even gradient with Dianella plantings at base of telegraph pole. Two benches are located alongside of path on decomposed granite and sandstone flagging creating a small gathering point. Bounded on northern side by three properties. Bounded on southern side by one property with a 1.8m green metal sheet fence. Mature planted trees and shrubs overhang walkway from neighbouring properties.

Accessible – concrete walkway with pram ramp access from road, sandstone paving. Requires vehicular access along walkway for maintenance to playground. Walkway border planting therefore needs to be tough species e.g. *Dianella caerulea, Calochlaena dubia, Hypolepis muelleri*.

- 1. Continue ongoing maintenance with removal of debris, weeds, rubbish and overhanging vegetation along walkway.
- 2. Maintain existing indigenous border plantings. Continue to replenish plantings as required e.g. *Dianella caerulea*, *Calochlaena dubia*, *Hypolepis muelleri*. (See Part One Appendix Castlecrag Plant List).
- 3. Monitor walkway to ensure even surfaces and repair trip hazards as required.

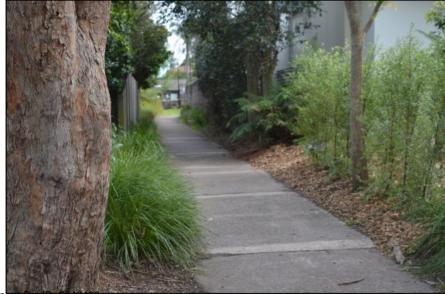
W-3- Between 9 and 11 The Parapet - access to Cortile Reserve

Width 3.05m. Concrete path1500mm wide. Boundary consists of various fence and hedge types. Mixture of native and ornamental plantings alongside path. One sign indicating access to Cortile Reserve.

- 1. Continue ongoing maintenance with removal of debris, weeds, rubbish and overhanging vegetation along walkway.
- 2. Maintain existing indigenous border plantings. Continue to replenish plantings as required e.g. Dianella caerulea, Calochlaena dubia, Hypolepis muelleri. (See Part One Appendix Castlecrag Plant List).
- 3. Monitor walkway to ensure even surfaces and repair trip hazards as required

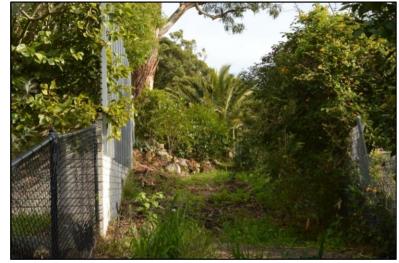
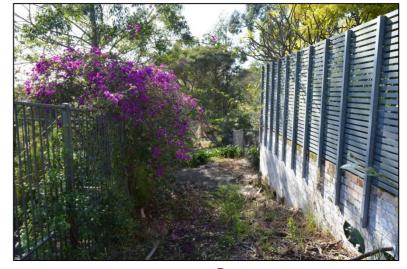
W-7 - Rear 11-15 The Redoubt, 2 The Rampart, 1 Sortie Port and 16-22 The Bastion - access to Casement Reserve

Width 3.05m walkway from Casement Reserve to rear 15 The Redoubt, a dead end. Mostly overgrown with garden escapes from adjacent properties, and exposed rock at the rear of 11 and 13 The Redoubt. Properties have wire fences, with the exception of 11 The Redoubt where garden walls have been carefully designed to provide privacy for the rooms in the house, leaving other parts of the grounds without boundary fences. Little apparent use, but a desirable adjunct to the rear of the properties.

Mostly inaccessible through the lack of use by residents.

- 1. Continue ongoing maintenance with removal of debris, weeds, rubbish and overhanging vegetation along walkway to ensure ongoing access.
- 2. Monitor encroachments from adjoining properties.

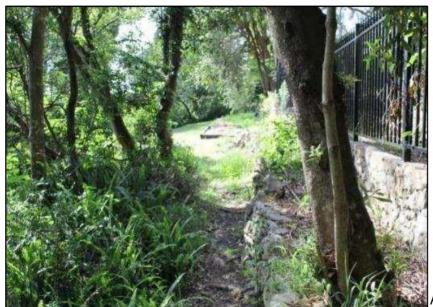
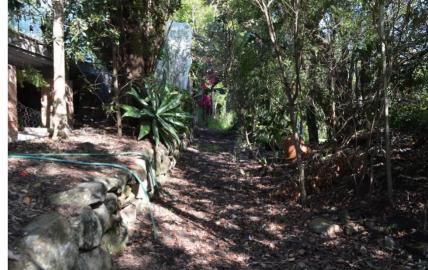
W-13- Rear 7-19 The Bastion and rear 97-109 The Bulwark - access to Embrasure Reserve

Width 3.05m. An open grassed path framed by vegetation from adjoining properties. Well maintained by adjoining owners. Some properties have low retaining walls in local stone, some wire fences and some properties remain unfenced. An outstanding example of a local pedestrian walkway which is maintained by adjoining owners.

- 1. Continue ongoing maintenance with removal of debris, weeds, rubbish and overhanging vegetation along walkway.
- 2. Monitor encroachments from adjoining properties and structural integrity of retaining walls of adjoining properties.

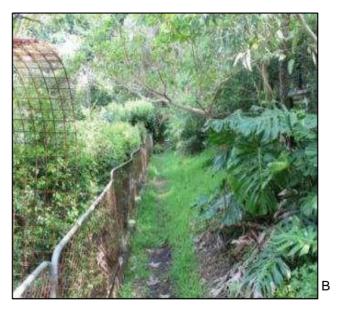
W-14 - Rear 21-25 The Citadel and rear 71-75 The Bulwark - connects Oriel Reserve to Gargoyle Reserve

Width 3.66m. Bushland track with vegetation extending from adjoining properties. Many boundaries without fences with some fenced.

- 1. Continue ongoing maintenance with removal of debris, weeds, rubbish and overhanging vegetation along walkway.
- 2. Gradually remove exotic border plants and replant with indigenous species, e.g. Dianella caerulea, Calochlaena dubia, Hypolepis muelleri. (See Part One Appendix - Castlecrag Plant List).
- 3. Monitor walkway for uneven surfaces and repair trip hazards as required.
